# High-performance, fast curing system for leading edge repairs

# 5711

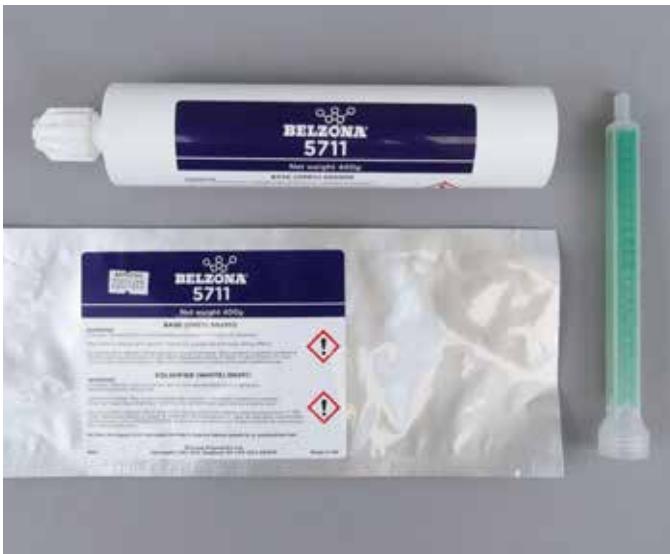
Belzona 5711 supplied in cartridge with static mixer.

It is supplied in a cartridge format, making it easy to apply, ideally suited for applicators using rope access.

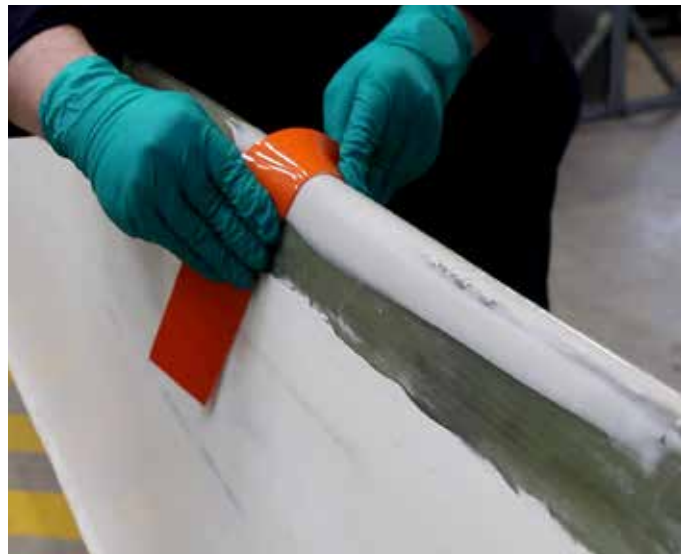
Easy to contour leading edge, no need for sanding.

This product has a good working life allowing it to be perfectly contoured to the leading edge, removing the need for sanding, eliminating a step in the repair process.
