BELZONA[®]
GREAT LAKES

**WASTEWATER
PUMP
EROSION PROTECTION**

PUMP COATING
SEPTEMBER, 2015

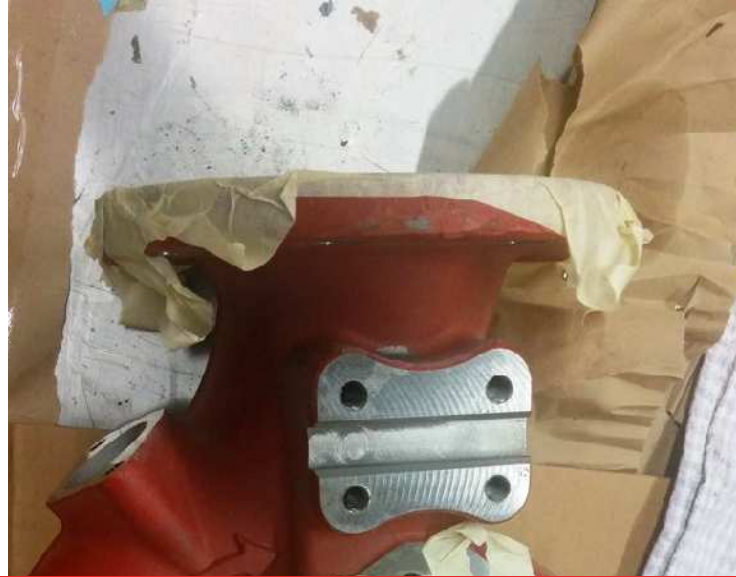
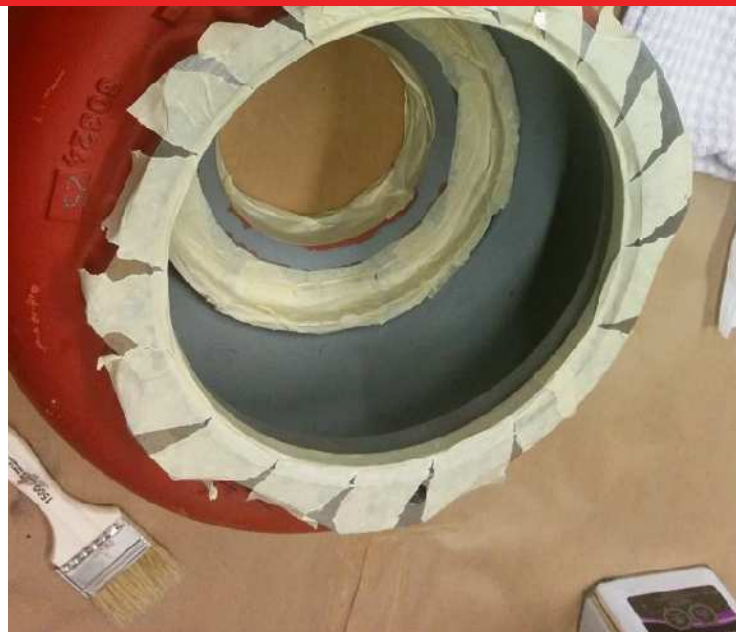
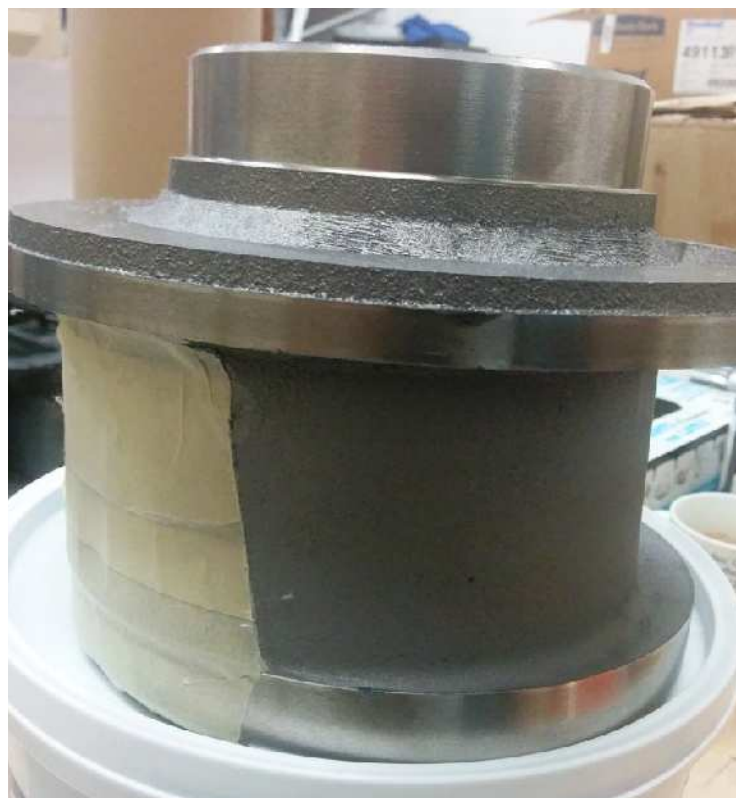
Previous supplied pumps had not met the customers expectations of longevity due to the impeller and volute being worn away by the erosion caused by wastewater.

The pump volute and impeller were masked off to protect machined surfaces and areas not requiring coating. The surface was then abrasive blasted to the required standard. The Belzona 1331 was applied as a two coat system. The first coat (Grey) was applied by brush at a DFT of 15 mils (375 Microns), followed by a second coat (white) also applied by brush at a DFT of 15 mils (375 microns).
